BUILDING & TIMBER PEST INSPECTION REPORT

PROPERTY INSPECTION ADDRESS
9 Fairy Street, Gwynneville

BUILDING AND TIMBER PEST INSPECTION REPORT TO AS4349.1 2007 & AS4349.3 2010

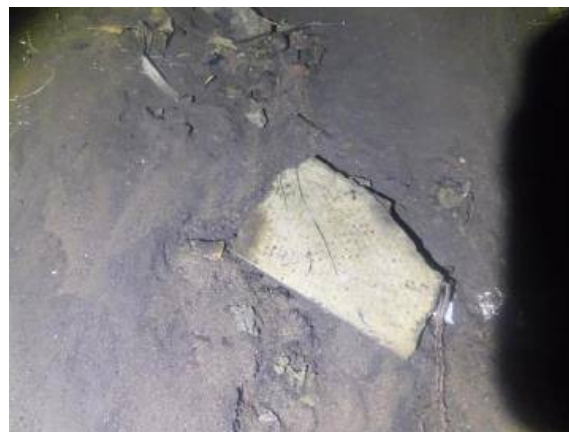
- Evidence of loose fibrous cement sheet debris within the subfloor area. This debris is likely to have Asbestos containing materials. We recommend an Asbestos audit be conducted to the property. If these sheets are tested positive for traces of Asbestos then this is a safety hazard and immediate action to remove / seal the asbestos will be required.

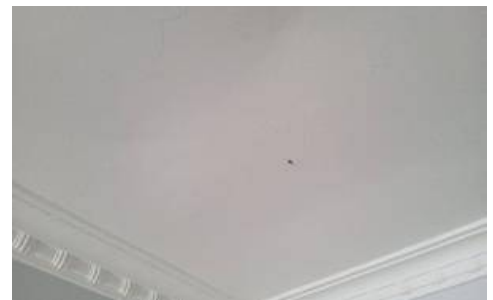
Some surface damage requires repair / repainting.

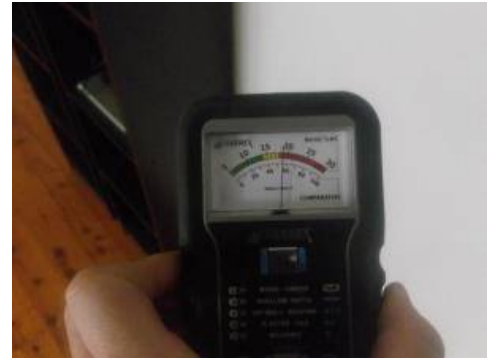
High moisture levels were detected in the wall at the rear of the ensuite bathroom shower. I recommend that a plumber be engaged to conduct a compression check on the combination and pipes and to also check the wetseal.

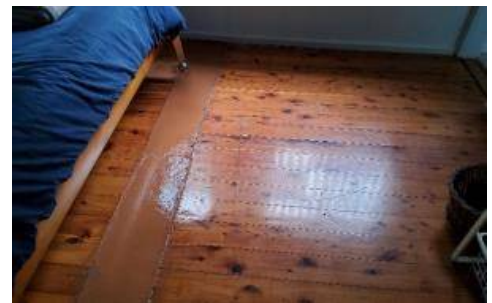
Squeaky flooring to various areas require refixing. We recommend a carpenter be engaged to assess the floor to remove the squeak.

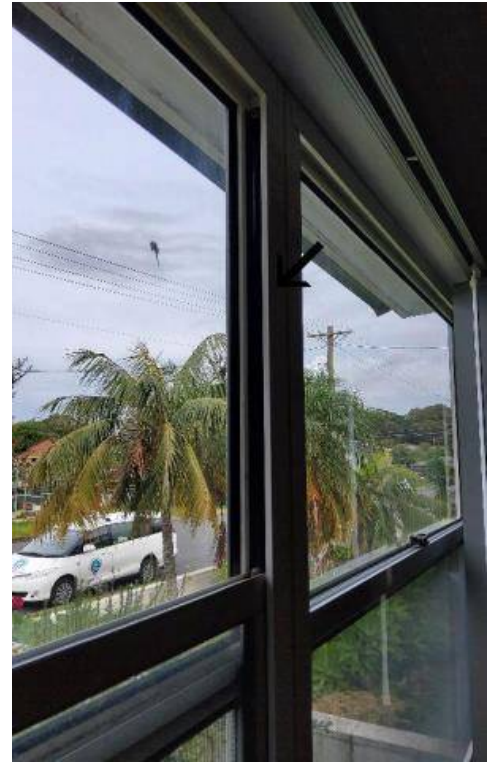
Its not uncommon for spiral balances to double hung windows to require rebalancing / adjusting or replacing. Ongoing maintenance required.

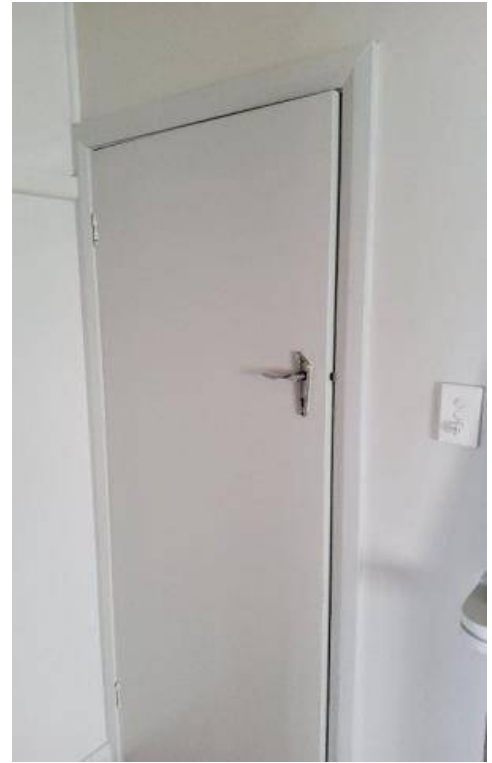
Slight binding to some doors requires adjustment.

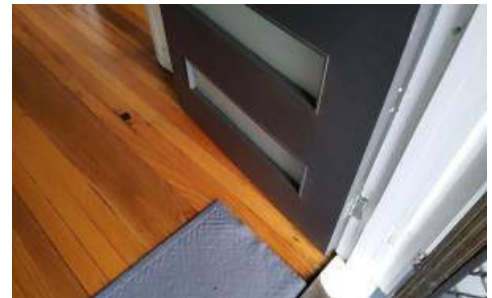
I highly recommend you have weather seals fitted to the external doors to assist in climate control to the internal areas.

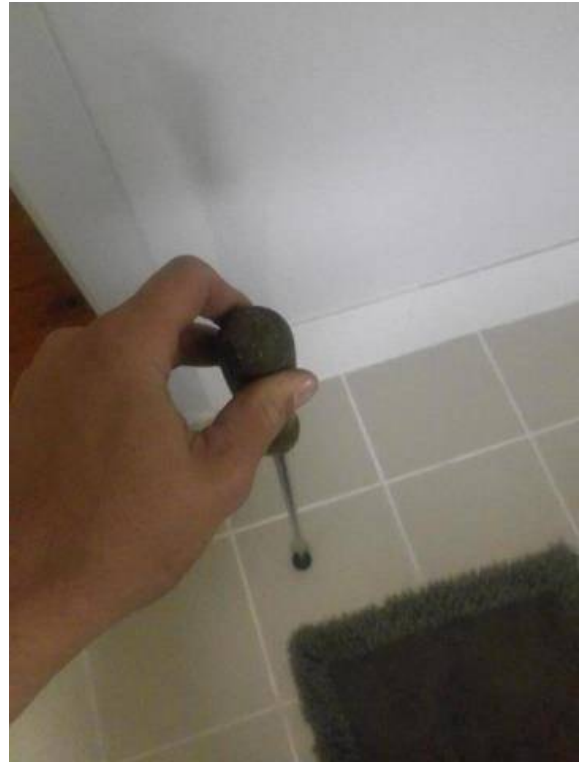
Drummy floor tiles to some areas. Drummy floor tiles are caused due to the adhesion to the tile either not being applied to the full tile at the time of fitment, or the tile adhesion has not bonded. Drummy floor tiles will generally crack over time and require replacing.

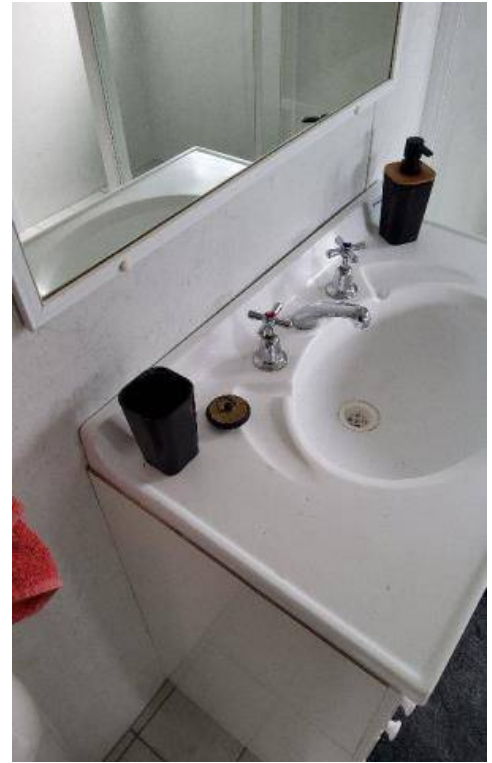
Junctions of vanity and wall sheeting require resealing with silicone.

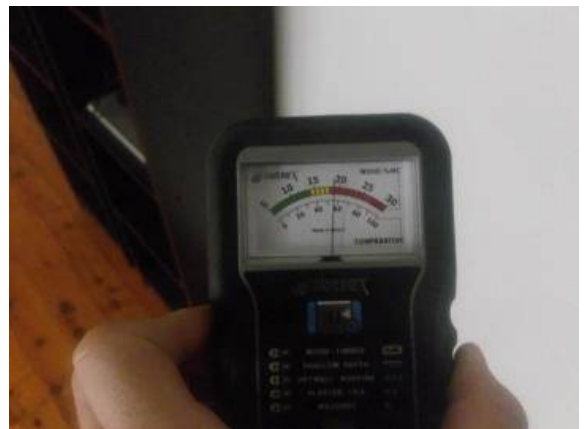
There are signs of high moisture levels in the wall at the rear of the ensuite bathroom shower. I recommend that a plumber be engaged to conduct a compression check on the combination and pipes and to also check the wet seal.

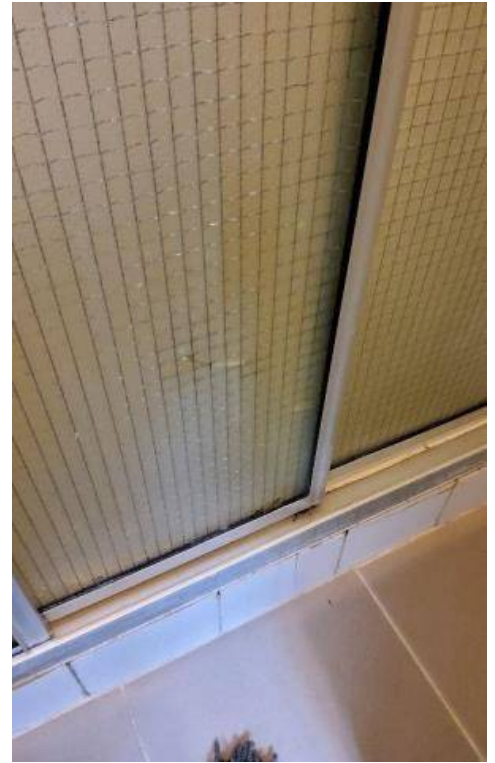
Cracks to slider panel requires replacing.

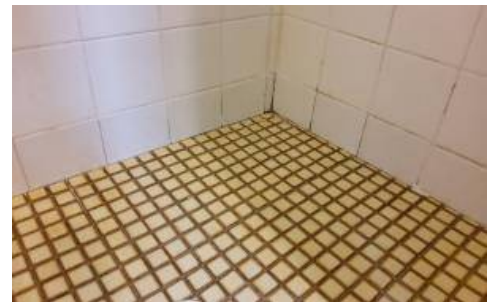
Junctions of shower floor and wall tiles require resealing with silicone.

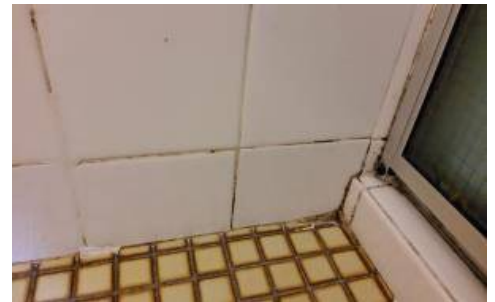
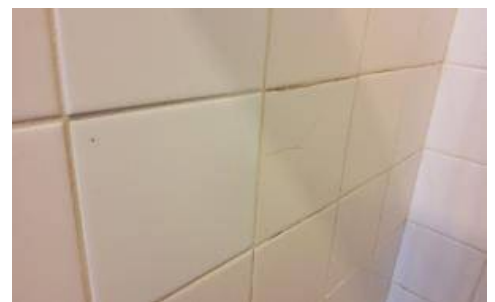
A number of wall tiles to the ensuite shower show of cracking and require replacing,

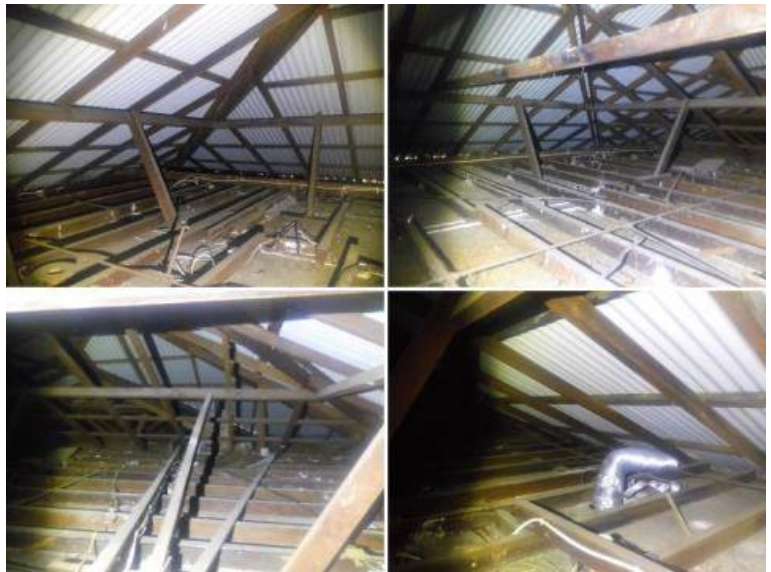
Older roof frames do not comply with current wind ratings. This roof is in satisfactory / typical condition for the age / construction date. Some sections show of deflection / movement away from their seated position. Some areas may require re-bracing, fitting in the future.

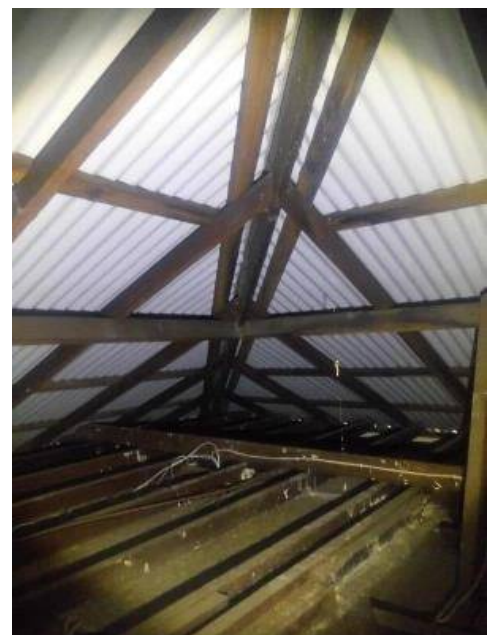
Sarking paper is fitted to the underside of the roof cladding and gable ends to protect the roof cavity from water / debris and foliage. Sarking diverts external conditions away from the roof void to the gutters and assists in climate control to the internal living areas. Sarking is fitted during construction / fitting prior to the roof cladding being fitted. Retrospective fitting of sarking is extremely difficult to achieve and only really able to be fitted if you are considering removing the existing roof cladding. Further consultation should be considered with a licenced roofing contractor.

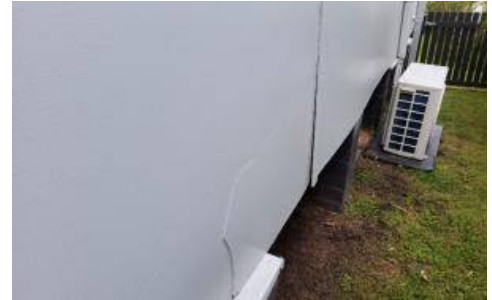
Various fibre cement sheets show signs of cracking / damage / holes and require repair. Note: Some of these lining materials may contain asbestos, please read the section on Asbestos in the Terms and Conditions of this report.

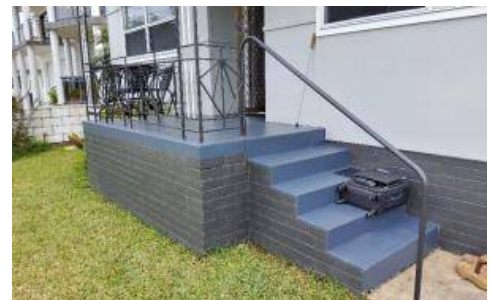
The external stair handrail & balustrade do not comply with current BCA standards however, they may comply with the date of construction. Although this report does not generally comment on items of compliance, this may become a safety issue / fall hazard and therefore was included in this report. We recommend you further investigate this matter and upgrade if/where necessary.

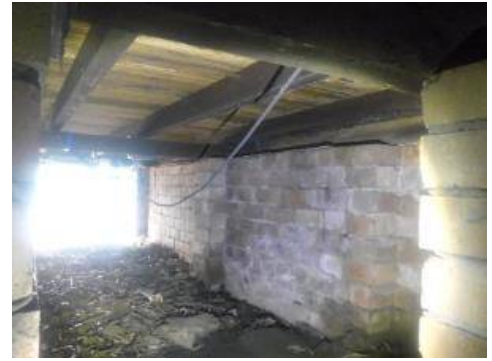
Older sub floor frames do not comply with current wind ratings. This framing is in satisfactory / typical condition for the age / construction date. Some sections show deflection / movement away from their seated position. Some areas may require re-bracing, fitting in the future.

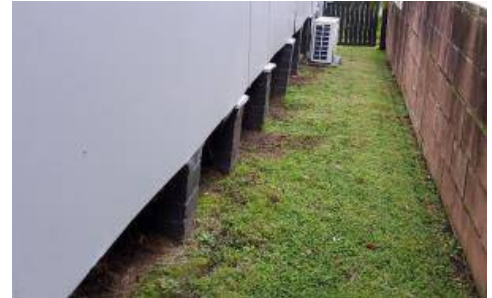
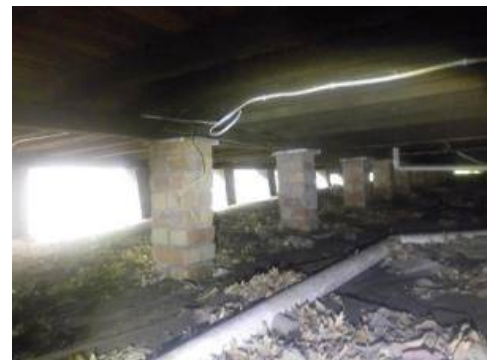
Some piers show signs of subsidence / movement. The movement is consistent with the age and construction type. Some piers will require repair, realignment / replacing. Have a licenced building contractor and or brick layer engaged to provide a scope of works to rectify in the near future.

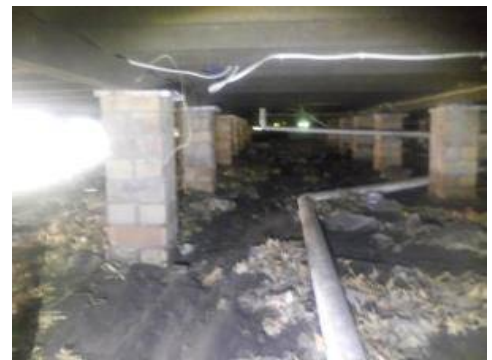
There are signs of damp soil within the subfloor area which indicate a potential drainage issue. Due to the topography of the site it is recommended to ensure that all surface water runoff is diverted away from the perimeter and subfloor of the residence. We recommend a landscaper be engaged to assess options for better drainage around the building.

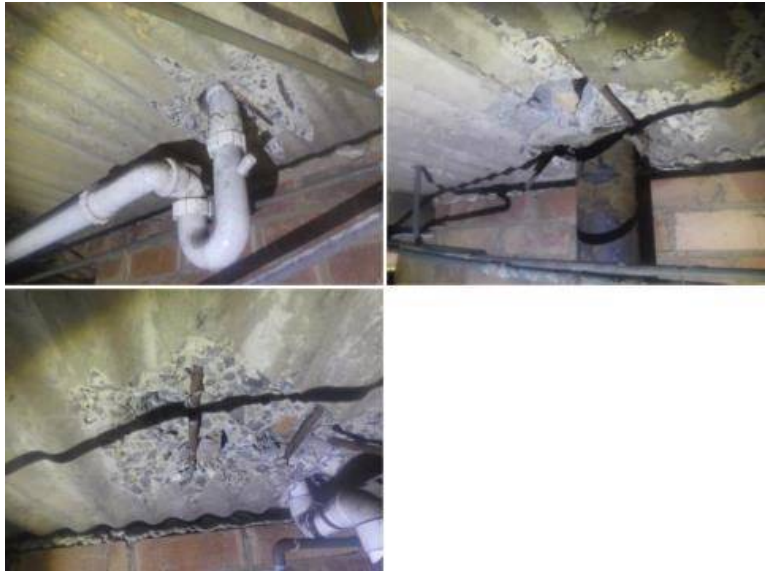
Some slabs show signs of exposed reinforcement which has rusted. This is the first stages of concrete cancer. I recommend you coat the exposed steel with kill rust, or galvanised sealer.

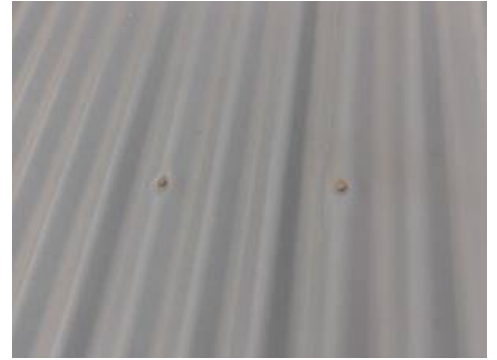
Some roofing screws show signs of rust and require replacement.

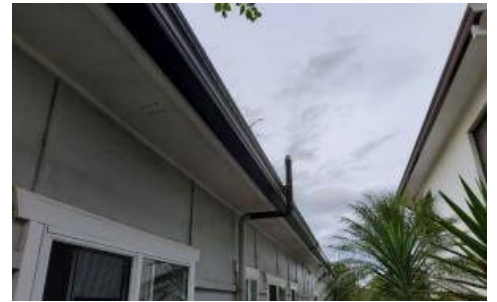
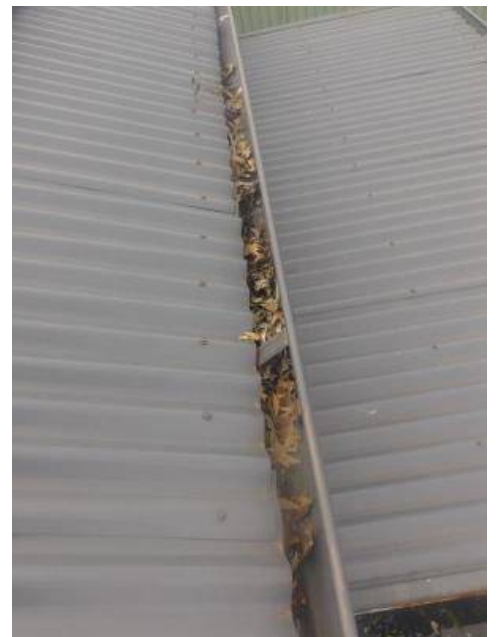
Some sections of gutter require cleaning.

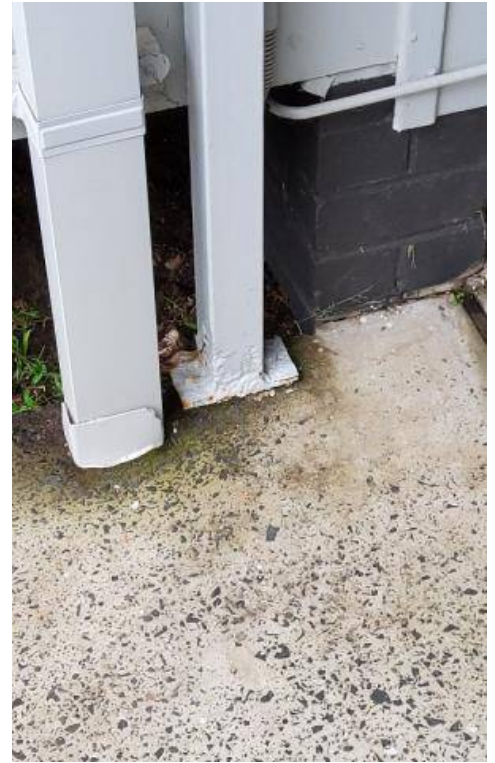
Some framing shows signs of rust and requires repair / painting with Killrust or equivalent.

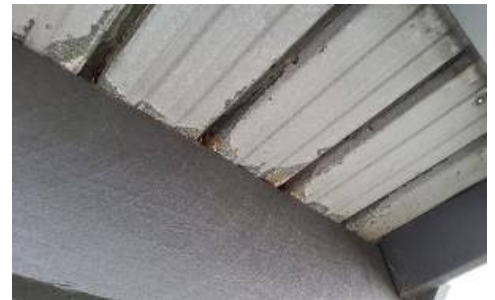
Some roof sheeting and flashings are rusted and requires repair / replacement.

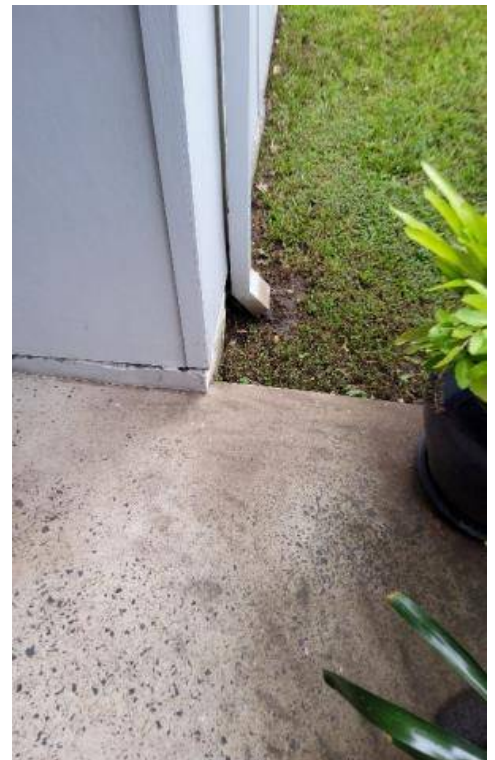
Extend downpipes to discharge storm water runoff away from the perimeter of the building and connect to a stormwater drain. We recommend a plumber / landscaper be engaged to assess this issue and determine a scope of work to connect / install an adequate drain.

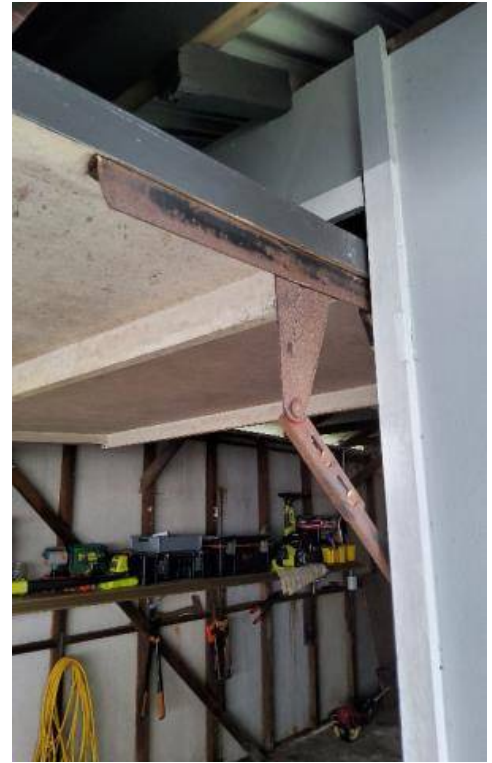
The hinge brackets for the tilt-a-door/s are rusting and require repair / painting with Killrust or equivalent.

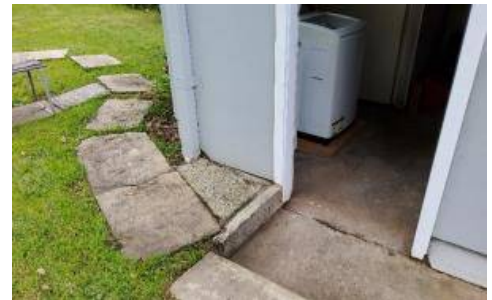
Large areas of the internal slab are below external ground level and highly subject to water penetration / ingress. You should monitor and have a licenced plumber / drainer to further inspect if / when the internal area experience flooding / pooling.

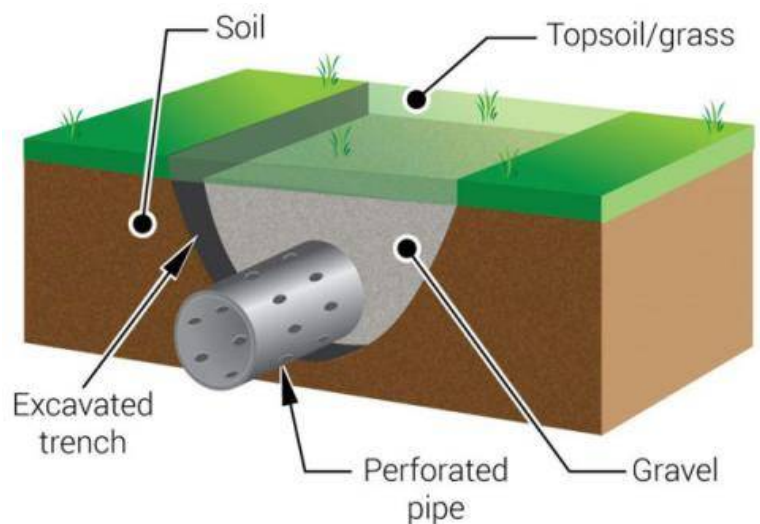
There are some low areas that should be monitored during wet weather, and if ponding occurs action should be taken to prevent ponding. This may require top dressing of the turf to eliminate low areas or installation of yard drain/s to this area (connect to existing stormwater) Refer to attached image for standard agg line detail.

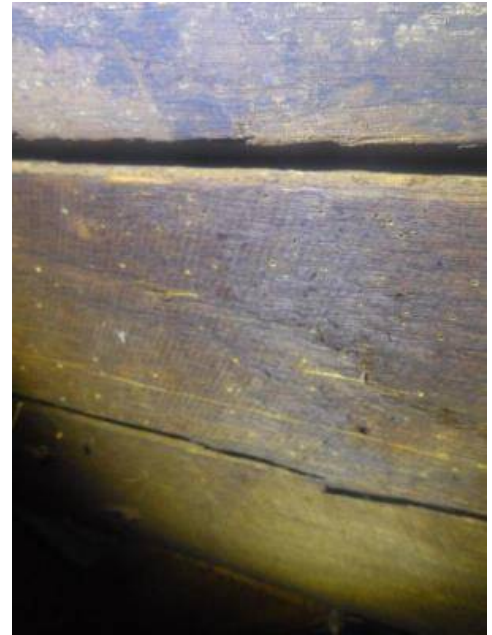
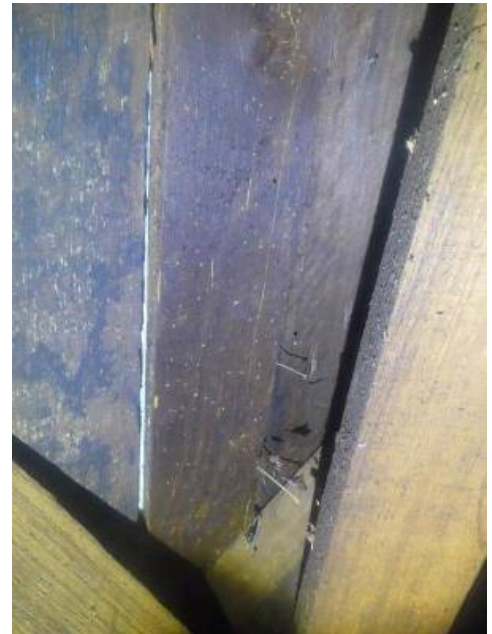
Some framing timbers.

The visible damage to the timbers appears to be moderate. Further damage may exist in concealed areas. Please refer to the definitions section of this report - Section 1.2 - Timber Damage.

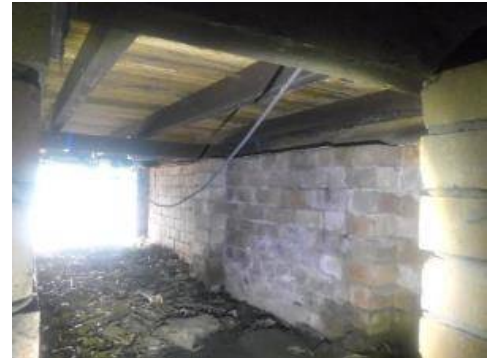
- Some sections of stripshielding are incomplete / missing. The purpose of stripshielding is to reduce the risk of concealed termite attack.

- We recommend the removal of loose timbers from the underfloor area as these predispose the property to termite attack.

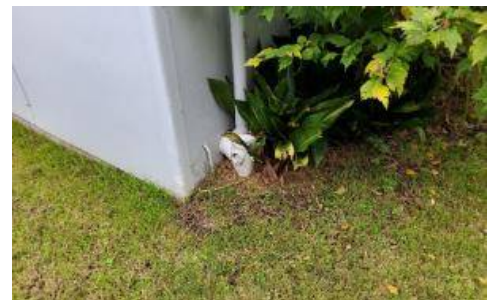
- We strongly recommend the slab edge be exposed as soil and vegetation can and may conceal termite entry.

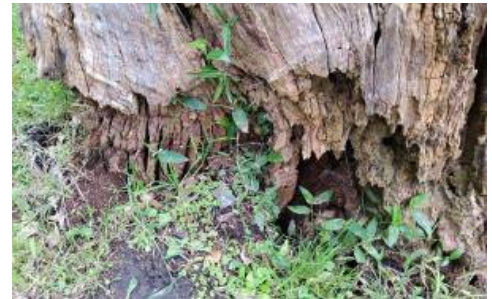
Various tree stumps.

The visible damage to the timbers appears to be extensive. Further damage will almost certainly exist in concealed areas. Please refer to the definitions section of this report - Section 1.2 - Timber Damage.

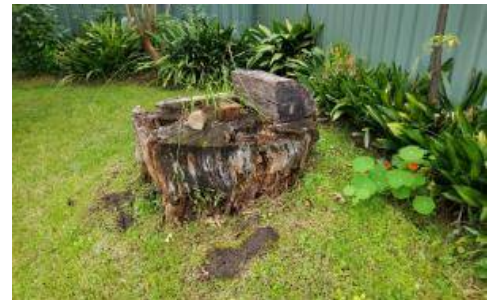
- Tree stumps should be removed as they provide an area for termites to establish a colony.

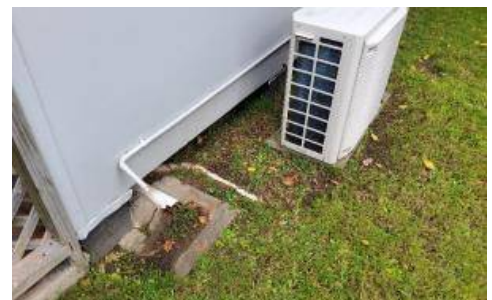
- The air-conditioning condenser discharges adjacent to the external walls. We recommend modification so that water is discharged over a drain.

- Divert all surface water runoff away from the perimeter of the building as moist soil conditions are highly conducive to timber pest attack.
