BUILDING & TIMBER PEST INSPECTION REPORT

PROPERTY INSPECTION ADDRESS
9 Fairy Street, Gwynneville

BUILDING AND TIMBER PEST INSPECTION REPORT TO AS4349.1 2007 & AS4349.3 2010

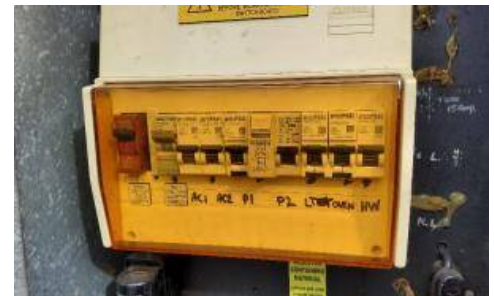
Electrical Safety Switch:

- Whilst not an electrician, an electrical safety switch is present to the building.

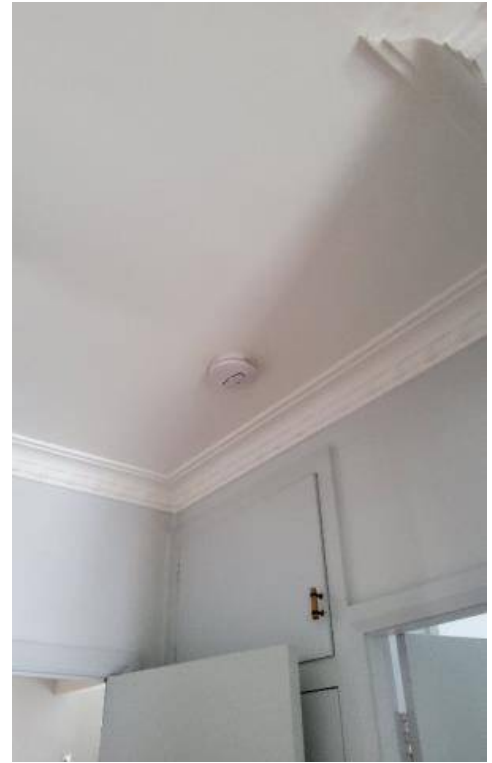
Smoke Alarms

- Smoke alarms are present within the house and located at the - Hallway, Back lounge room.

AS 3786 - Advises that Smoke Detectors / Alarms are required for all buildings where people sleep. Any existing smoke alarms manufactured more than 10 years ago should be replaced with photo electric smoke alarms which comply with Australian Standards (AS) 3786-2014.

An electrician should be consulted to advise on those installed or install new detectors / alarms if / where required.

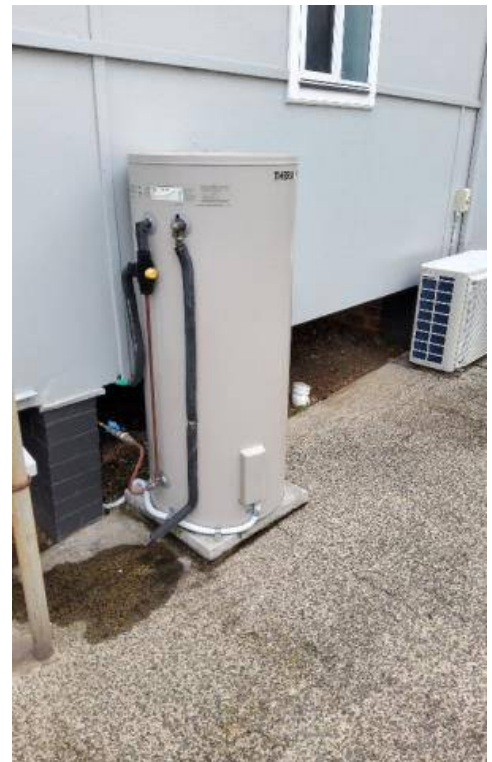
Hot Water Service

Electrical Hot Water Service. (In general Electric Hot water storage services have a life expectancy of 10-15 years. Have a licenced plumber further inspect and comment on operation / service)

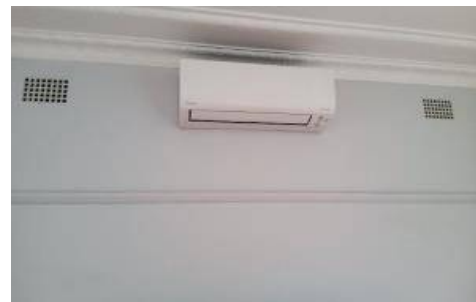
Heating/Cooling

Split system A/C units appear fitted. Further inspection by a licenced Air conditioning technician highly recommended as inspection of these services is excluded from this report.

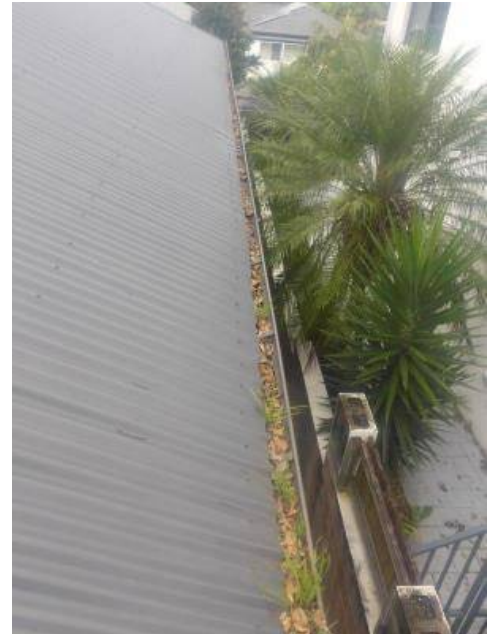
Some sections of gutter require cleaning.

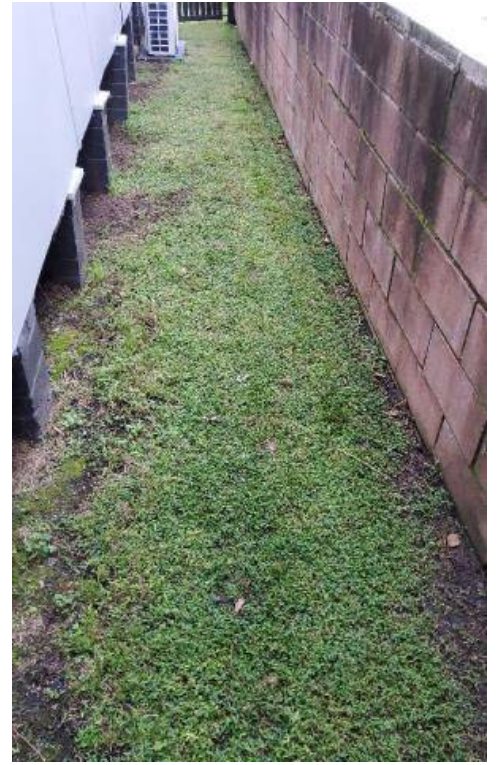
There are some low areas that should be monitored during wet weather, and if ponding occurs action should be taken to prevent ponding. This may require top dressing of the turf to eliminate low areas or installation of yard drain/s to this area (connect to existing stormwater) Refer to attached image for standard agg line detail.
